# **BRAKE FLUID COMPATIBILITY STUDIES WITH ADVANCED BRAKE SYSTEMS**

## **INTERIM REPORT TFLRF No. 473**

**Contract No. W56HZV-09-C-0100 (WD34)**

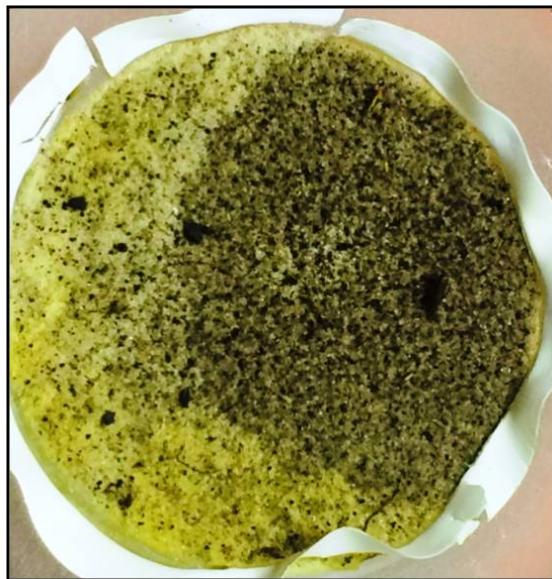
**Figure 19. Filtered Residue from Used HSF**

Figure 19 shows the used HSF fluid that was filtered for analysis. Elemental analysis of scraped material from this filter paper, shown in Figure 20 and Table 5 confirms a high amount of Si that could be potentially from the brake fluid. Therefore, in order to determine the presence of elastomer in the residue, the scraped material was subjected to SEM imaging which would confirm the physical presence of elastomers, followed by subjecting the residue to XRD which would confirm the actual chemical identity if the elastomer were present.

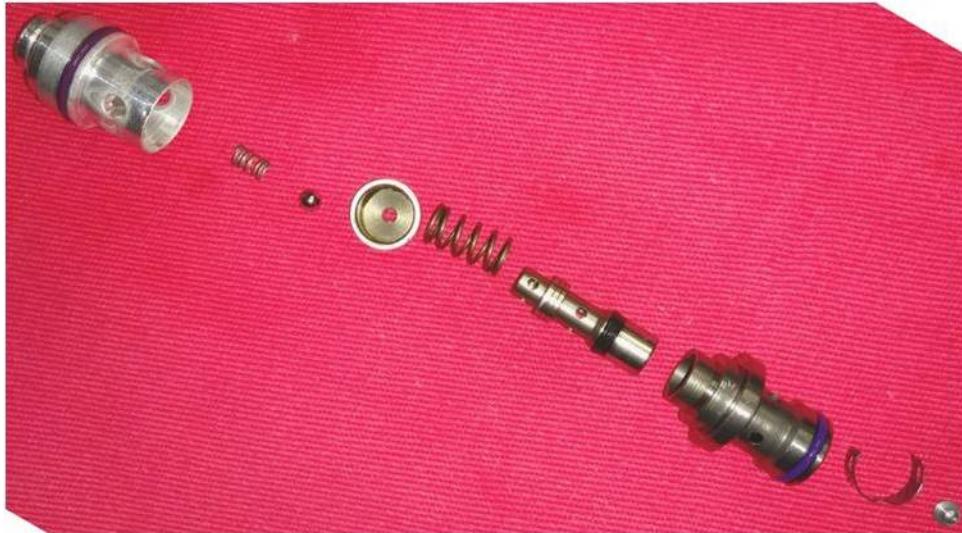
**Figure 23. Disassembled Hydraulic Power Brake Pumping Element**

The two pumping elements from the HSF test article were disassembled and inspected for wear patterns. The disassembled components of a pumping element are shown in Figure 23. A close up image of the pumping element plunger is displayed in Figure 24. There appeared to be some polishing wear on the large diameter sections, some of which can be seen on the left side of the plunger. The wear on the right side of the plunger was diametrically opposite, to the right of the black seal.

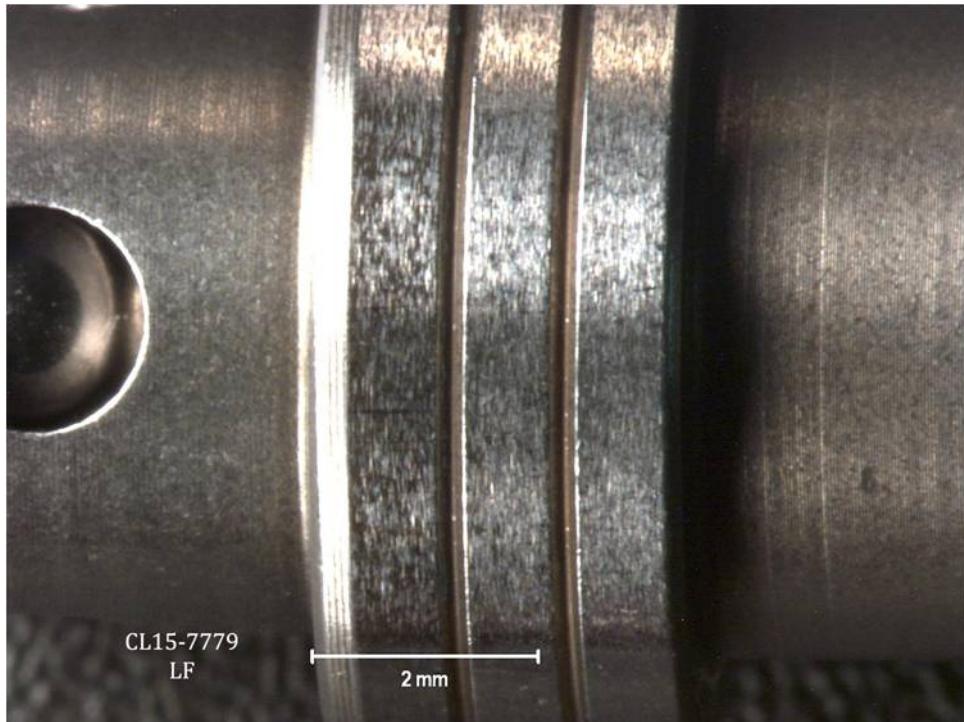
Figure 28. Detail of the Baseline LF Plunger Pumping Section Polishing and Wear

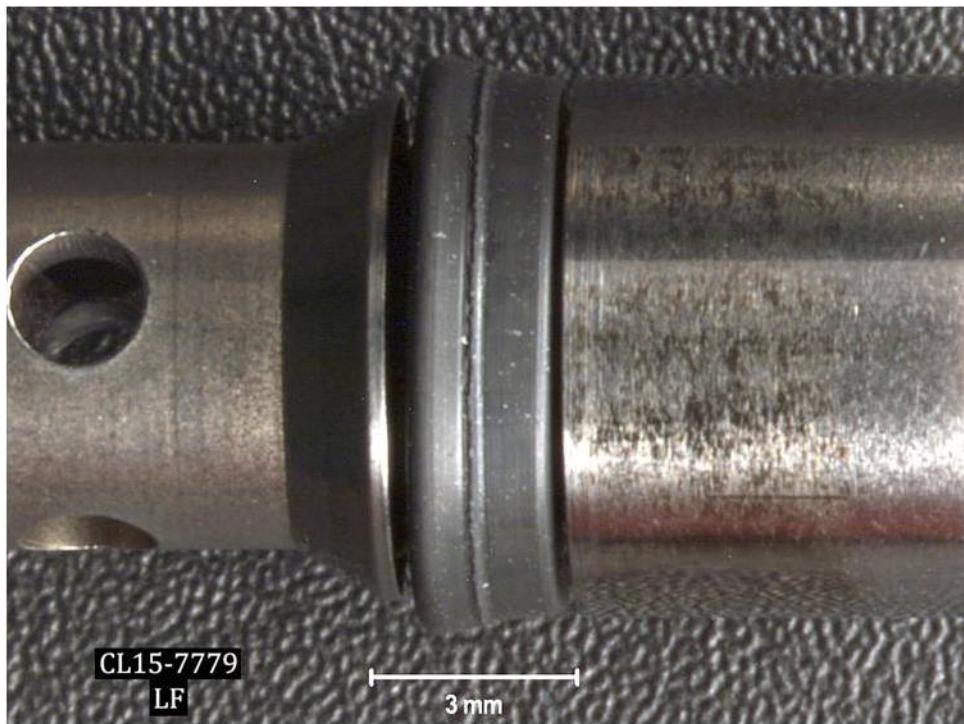
The LF pumping element barrel was cross-sectioned using Wire Electrostatic Discharge Machining (WEDM). The wear between the piston follower section and the barrel are shown in Figure 31 towards the left edge of the image for the HSF LF pumping element barrel. The corresponding baseline LF barrel shows very little wear as seen in Figure 32. A closer view of the elastomer distress for the HSF fluid is shown in Figure 33. It is postulated that debris from the barrel/plunger wear at the follower end was what caused the elastomer distress. A closer view of the elastomer distress for the baseline fluid is shown in Figure 34.

Figure 34. Elastomer on LF Plunger from Baseline Testing

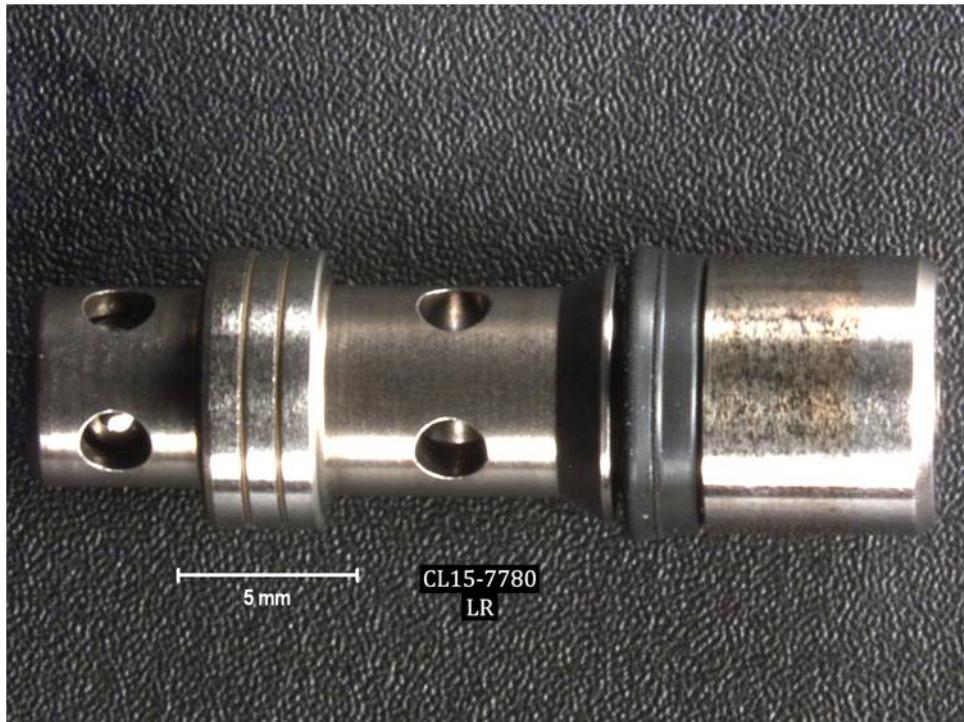
The overall condition of the HSF LR plunger is seen in Figure 35, with wear seen on both the pumping (left) end and the follower (right) end. More wear was evident on the LR plunger after HSF testing. The baseline LR plunger is shown in Figure 36 with very little polishing evident. A closer image of the HSF LR plunger pumping section wear is seen in Figure 37, and the similar baseline LR plunger section in Figure 38. Magnification of the HSF LR plunger follower wear is shown in Figure 39, where towards the left edge of the image distress to the elastomeric seal was also observed as before. The wear on the baseline LR plunger was minimal and the elastomer distress was also minimal as seen in Figure 40. More wear was evident on the LR plunger than the LF plunger, especially on the follower section, with the HSF brake fluid. Again it appeared the area around the follower end was only lubricated by fluid that was wiped onto the barrel bore surface by the seal. For the baseline fluid, the LR and LR plunger wear was similar. There was more overall plunger wear with the HSF fluid than the baseline fluid.

Figure 36. LR Plunger Overview from Baseline Testing

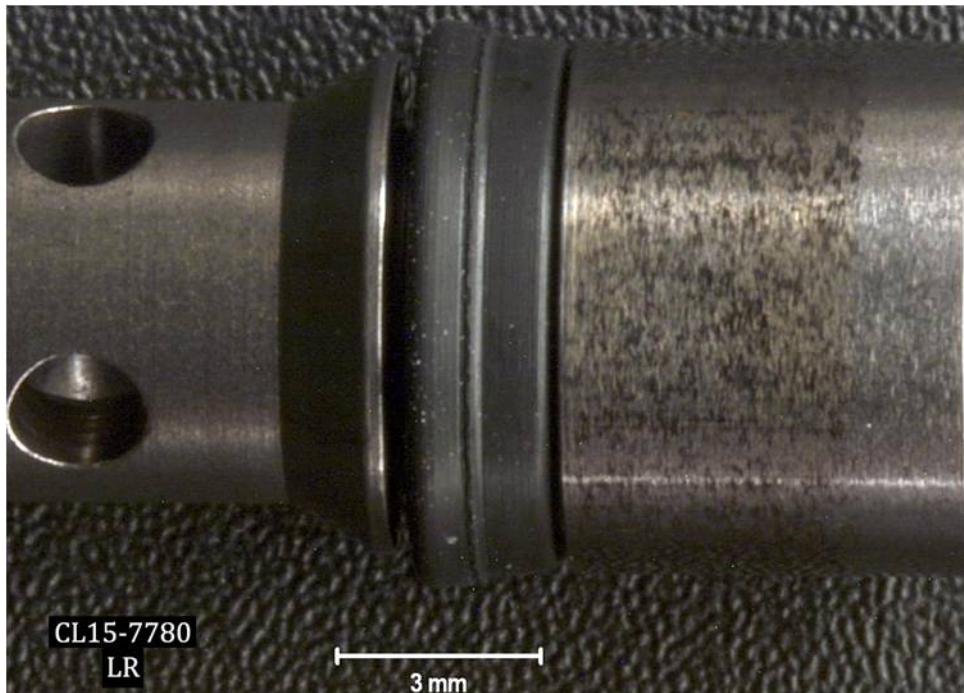
The LR pumping element barrel was also cross-sectioned using WEDM. The wear between the piston follower section and the barrel are shown in Figure 41 for the HSF fluid. Towards the left edge of the image for the LR pumping element barrel scuffing and material transfer was evident. The corresponding baseline LR barrel shows very little wear as seen in Figure 42. A closer view of the elastomer distress is shown in Figure 43. It appears evident debris from the barrel/plunger wear at the plunger follower section caused the elastomer distress. A closer view of the minimal LR plunger elastomer distress for the baseline fluid is shown in Figure 44.

Figure 44. Elastomer on LR Plunger from Baseline Testing

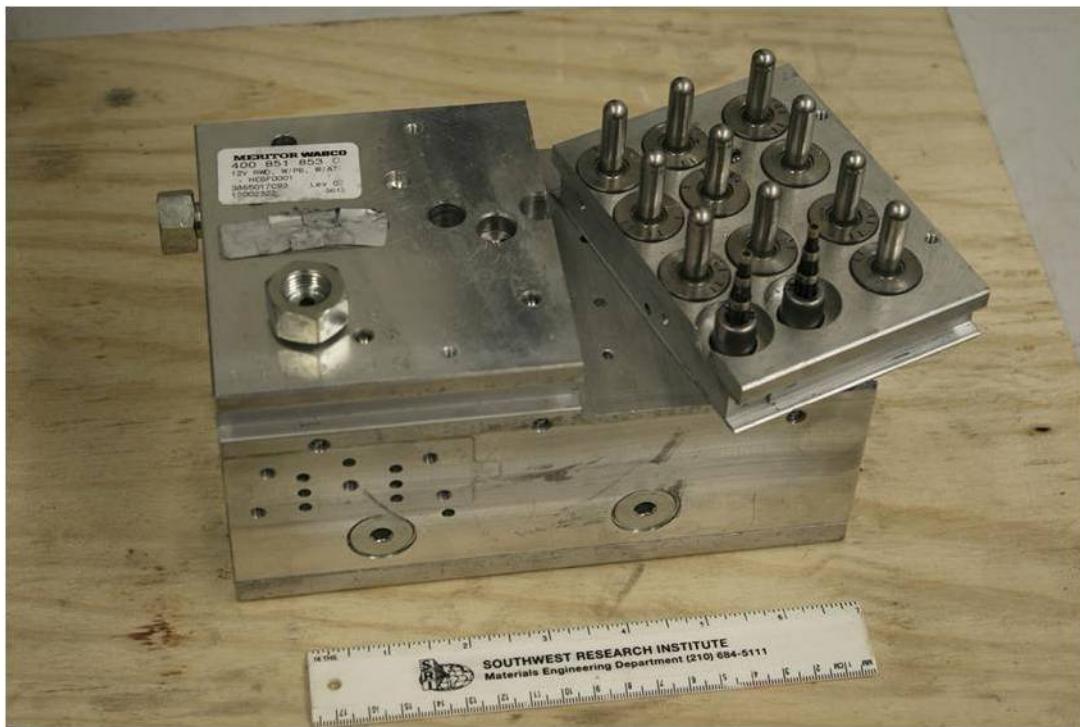
Figure 45. Valves sliced from the main block using a band saw

The following figures document how the servo valves and filters were removed from the HPB block. Figure 45 shows how the valve section was sliced off the HPB block with a band saw. The slice with the band saw was below the depth of the servo valve machining. The valves were numbered individually as shown in Figure 46, then parallel cuts were made between valve rows. Each valve was then isolated by making cuts perpendicular to the row cuts as shown in Figure 47.

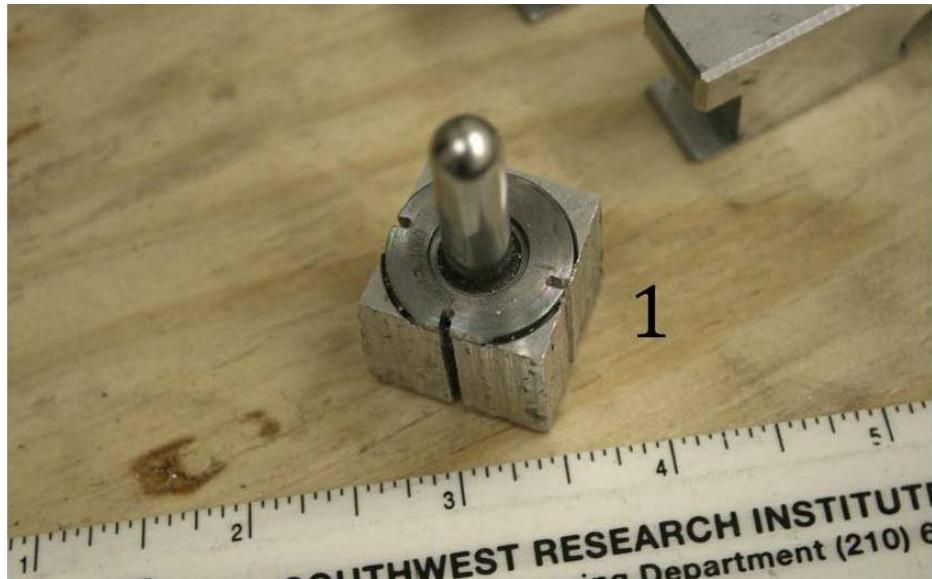
Figure 48. Small cuts were made on 3 sides as indicated

After each valve was isolated, three notches were made around each individual valve body, Figure 48, to assist with valve removal. A hammer and chisel was then used to separate the aluminum body from the valve as shown in Figure 49. The filters from servo valve bodies 4,5,6, and 10 bodies were analyzed using FTIR as discussed previously.
